KOOTENAI DEVELOPMENT IMPOUNDMENT DAM
JANUARY 2011 ROUTINE OWNERS INSPECTION

Prepared for: The Remedium Group

Prepared by: Kurt Hafferman, P.E.

Inspection Date: February 04th, 2011
Report Date: February 07th, 2011

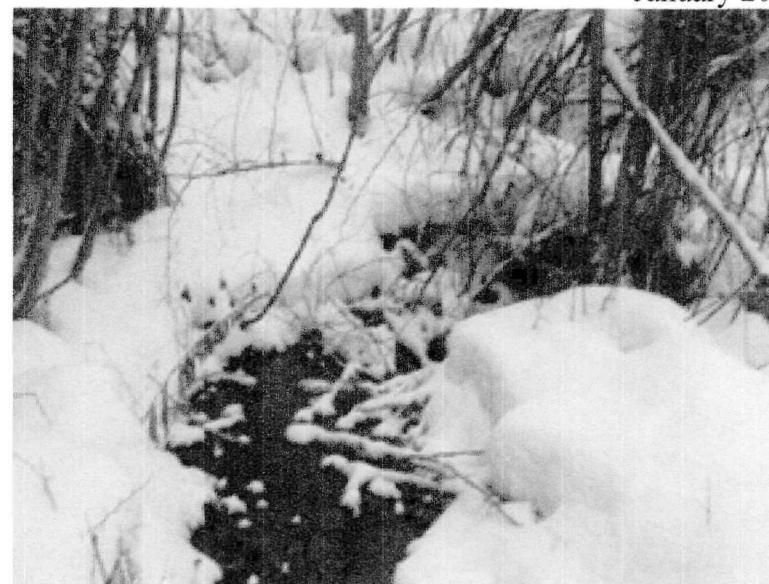
F-Seep - downstream

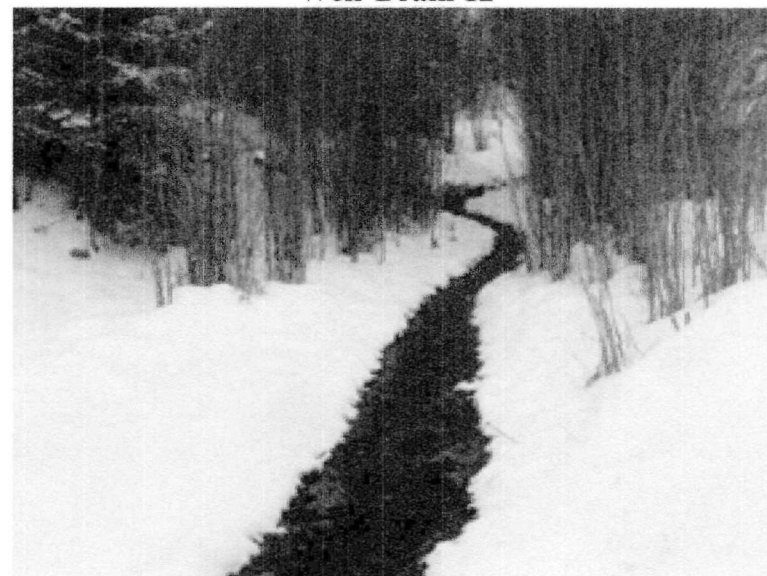
Flows below Weir 12

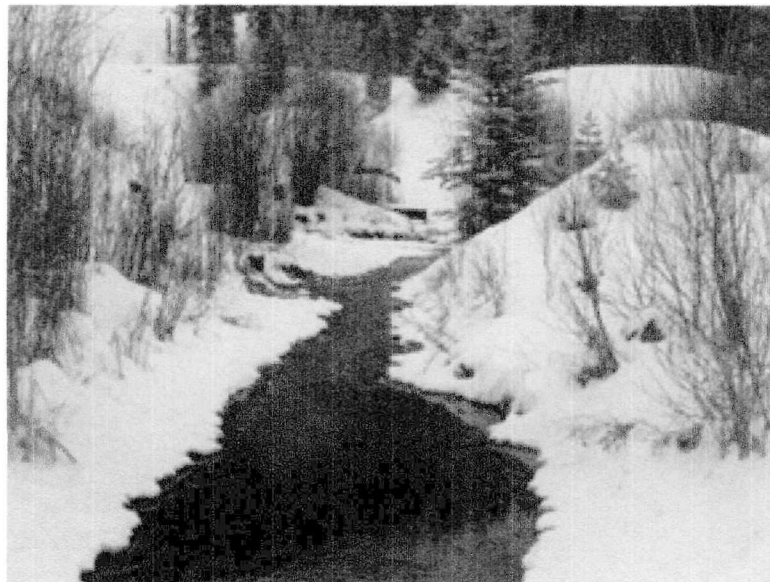
Flows downstream Drain 11

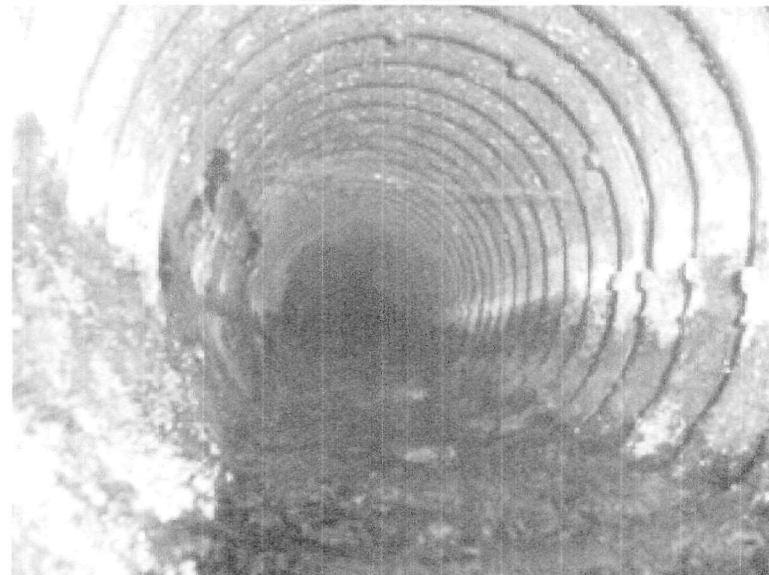
Inside Drain 10

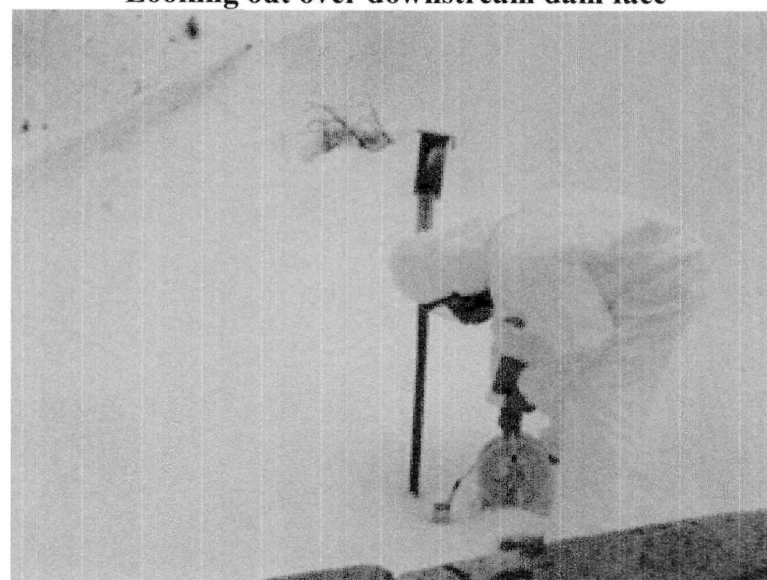
Piezometer Reading

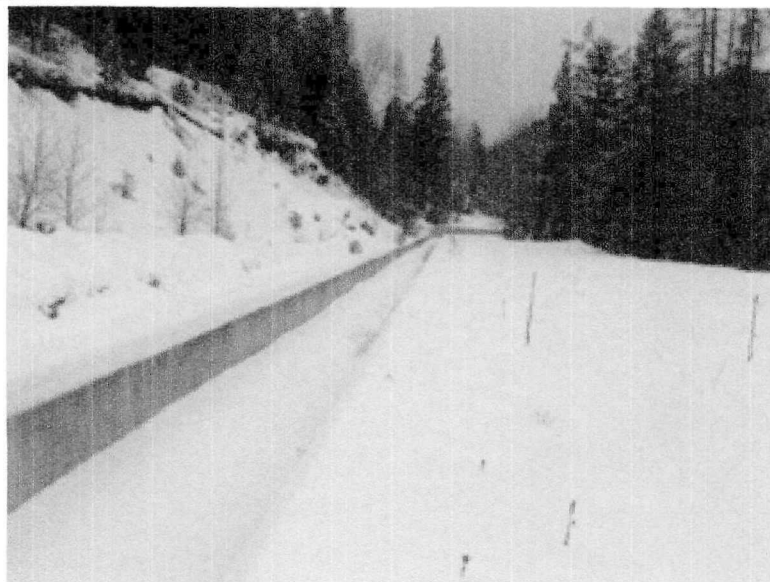
Outlet box culvert

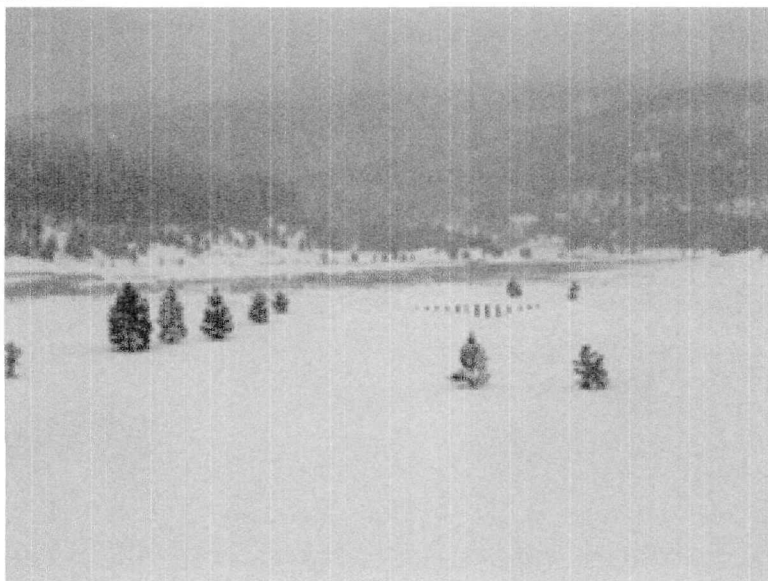
Upstream crest of dam looking right

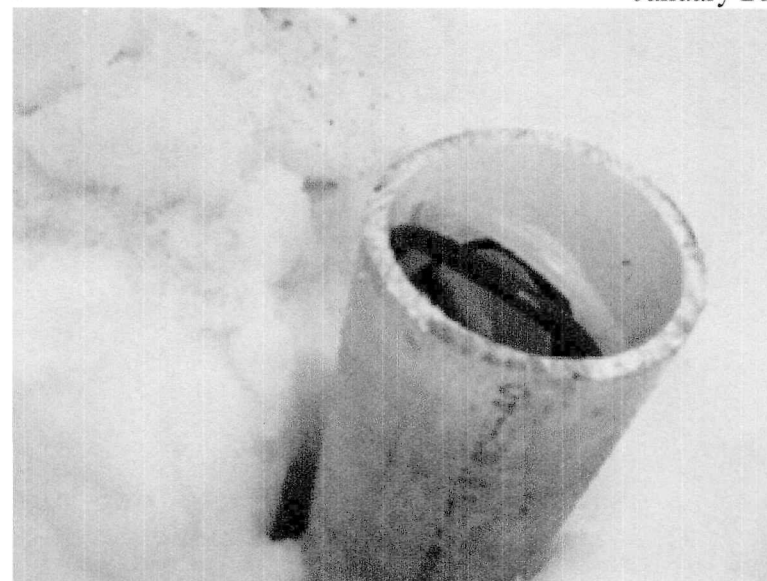
Reservoir trash rack

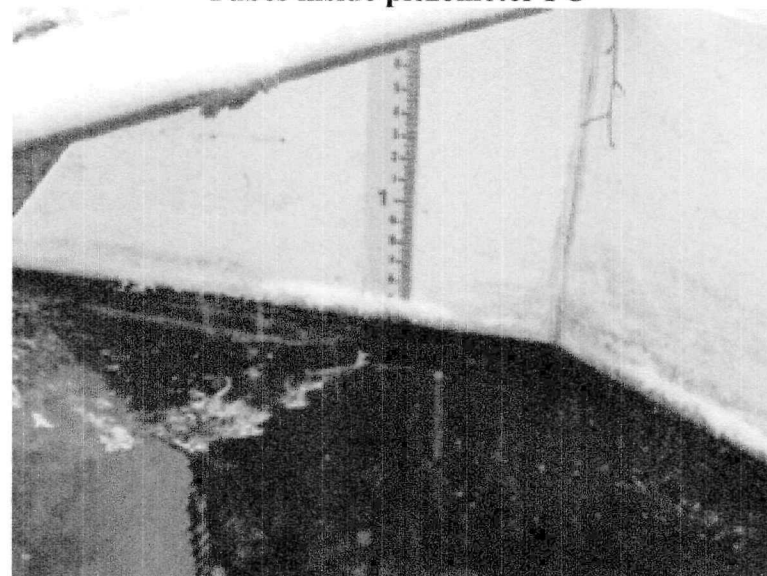
Piezometer PO

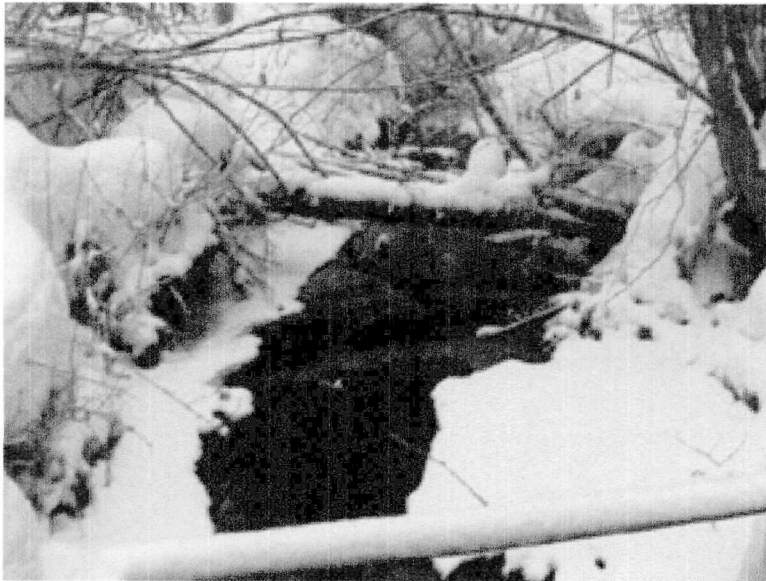
URC-02 Gauge

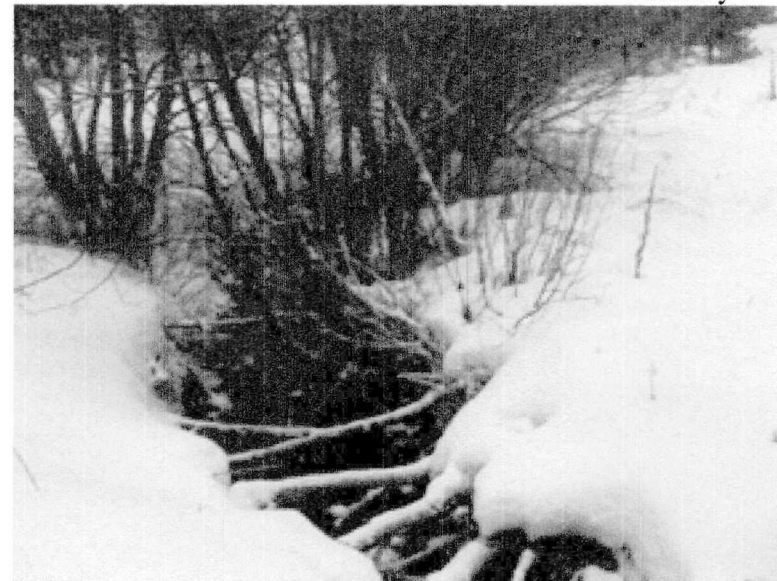
Upstream URC-02

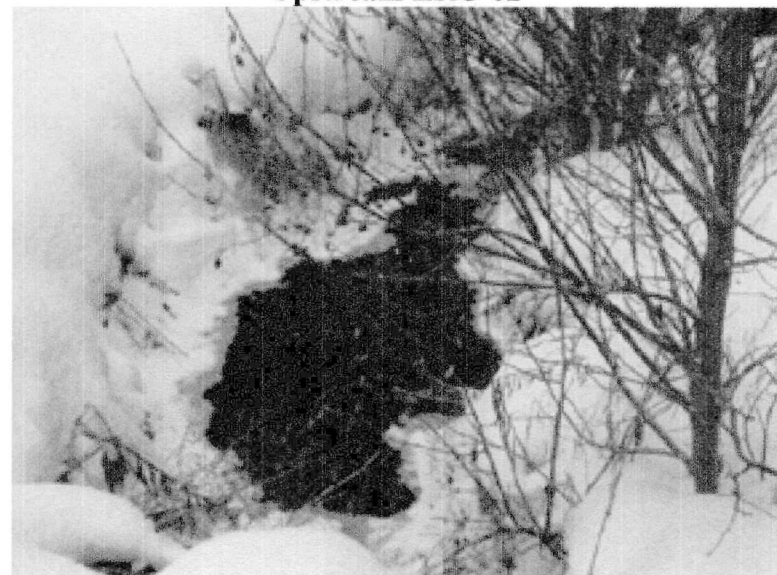
URC-02 Flume looking upstream

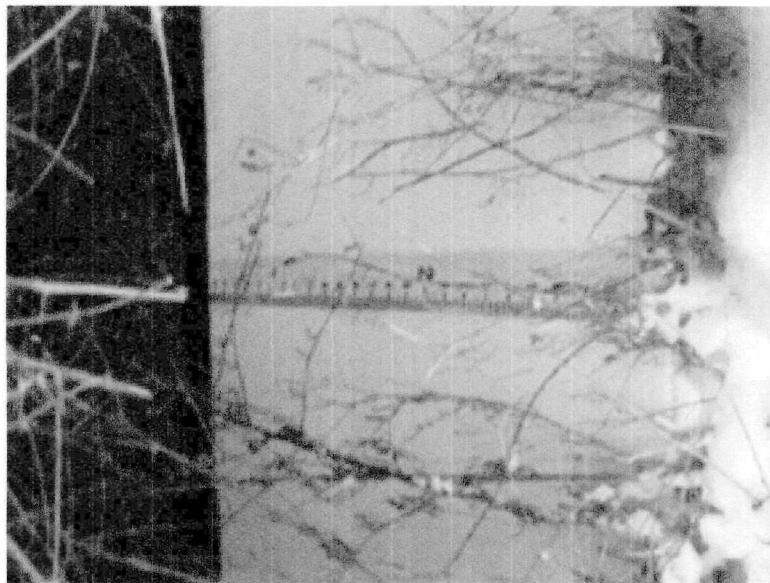
Downstream LRC-02

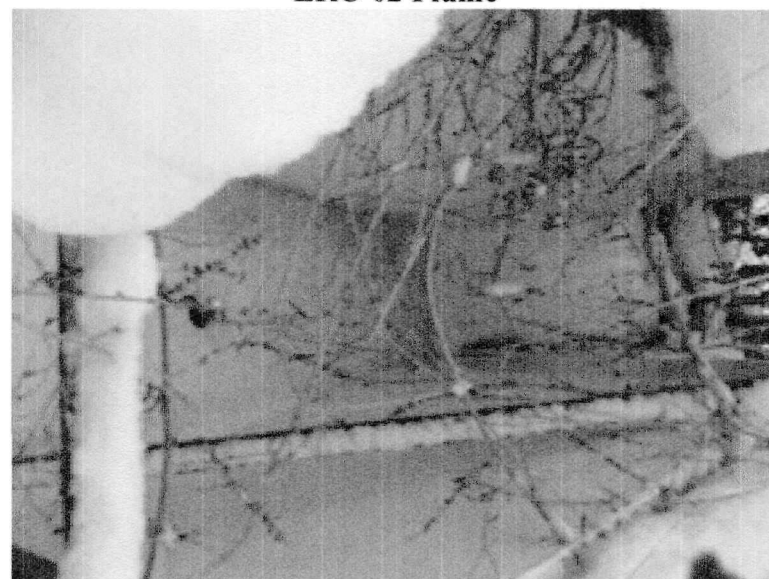
LRC-02 Inlet

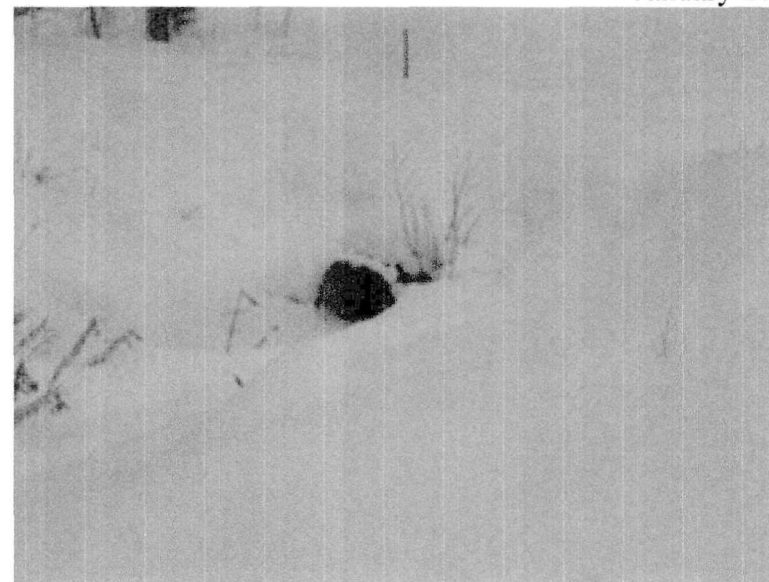
Culvert downstream of CC-02
